# Manhole Inspection Summary

Manhole # S35W\_\_039MH

Insp Date: **2/29/08 8:31 AM**

**Location** Address: **1801 s hanover**

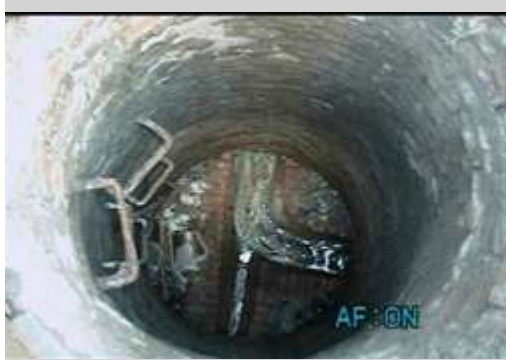
Defect 1

Condition: **Cracked**

Infiltration: ☐ None ☐ Joint ☐ Cracks ☐ Mortar ☐ Roots ☒ **Wall**

☒ **Corroded**

corroded steps; barrel wall infiltration

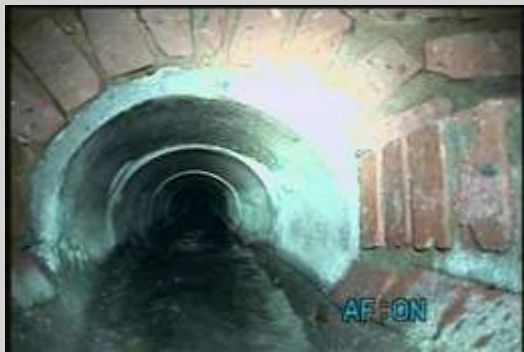
12 O'Clock Outflow

8 in. Circular Gravity Sewer  
Pipe Out @ 12 O'Clock

Pipe Material: **Clay** ☐ Pipe Lined

Invert Depth: **12.20** (ft.) Flow Characteristics: **Fast**

Infiltration: **None** Pipe Seal Cond: **Unknown**

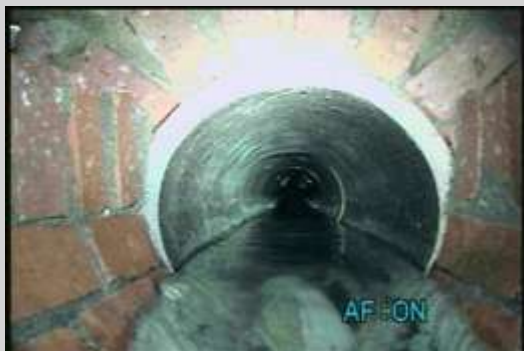
3 O'Clock Inflow

8 in. Circular Gravity Sewer  
Pipe In @ 3 O'Clock

Pipe Material: **Clay** ☐ Pipe Lined

Invert Depth: **11.70** (ft.) Flow Characteristics: **Fast**

Infiltration: **None** Pipe Seal Cond: **Unknown**

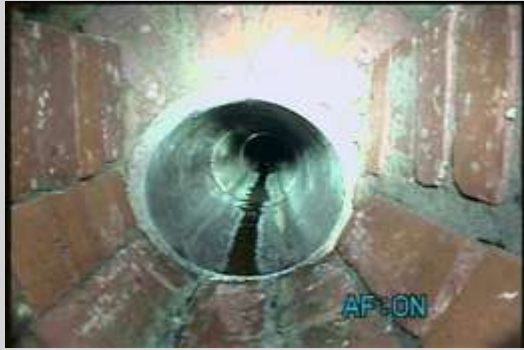
6 O'Clock Inflow

8 in. Circular Gravity Sewer

Pipe In @ 6 O'Clock

Invert Depth: **11.80** (ft.) Flow Characteristics: **None**

Connects To: **Dead End**
